# TECHNICAL MEMORANDUM

TO: Olaf Sweetman, PE Lane County Public Works  
FROM: Carl Hughes, PE, DOWL  
DATE: March 12, 2026  
PROJECT: Stewart and Currin Covered Bridges Cost Estimating

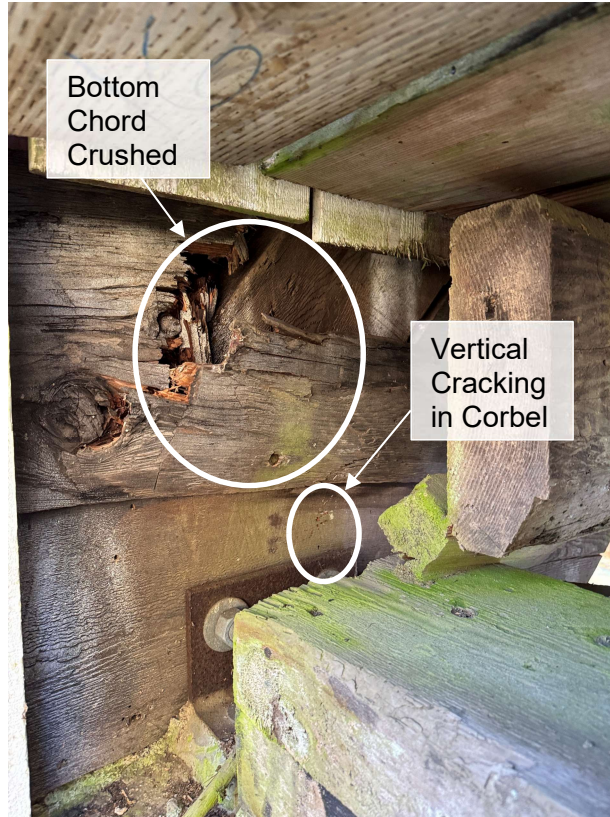
As shown in **Figure 1**, the south bottom chord at Bent 4 has experienced significant decay and crushing, causing the truss diagonal to punch through the chord. This failure has compromised the structural integrity of the truss. The corbel supporting the bottom chord and diagonal was intended to handle only bearing-type loads and is now subject to additional flexural stresses because of the bottom chord failure. It exhibits signs of overstress in the form of vertical cracking at the maximum flexural stress location.

**Figure 1: Crushing Failure of South Bottom Chord at Bent 4**

The local failure has resulted in additional global effects. The whole structure has racked, which is apparent when looking at floor beam 3 (the floor beam adjacent to the bottom chord failure) from the northeast corner of the bridge. The floor beam has visibly deflected downward at its south end. **Figure B3** in Appendix B tries to capture this but it is much more apparent in person than in the photograph.

To open the Stewart Covered Bridge to inspectors, an alternative load path for the south truss will need to be established. DOWL recommends using a similar approach to the method used by the contractor on the County's Wildcat Covered Bridge as seen in **Figure 3**.

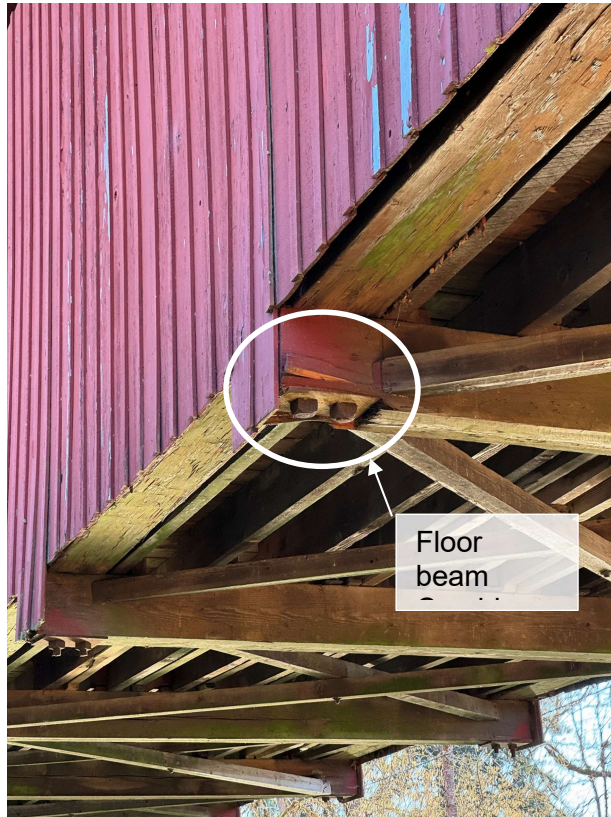
As shown in **Figure 2**, the east end of floor beam 6 exhibits approximately 3 inches of crushing and shearing deterioration at the hanger rod connection plate.

**Figure 2: Floor beam Crushing and Shearing at Hanger Rod Connection**

These local failures have resulted in warping of the deck system. There is visible sag in the deck over the east end of floor beam 6.

in the floor beam may indicate that condensation is forming on the vertical hanger rods, leading to decay and crushing of the floor beam. Since the hanger rods go through the bottom chord and the floor beam, a similar level of decay could be present in the bottom chord. Deterioration of this member would lead to a catastrophic failure.

As part of the temporary support to stabilize the bridge, DOWL recommends removing the deck and stringers from the two north-most bays, which are supported by the failing floor beam. Four additional threaded rods will be placed on either side of each end of the floor beam to connect the top and bottom chord (L6 to U6 nodes) and unload the existing two threaded rods at each end. Once this system is in place, the existing floor beam will no longer carry load along its length or at its connections other than its self-weight. DOWL recommends replacing the floor beam and removing the temporary support as a part of the temporary work for the bridge.

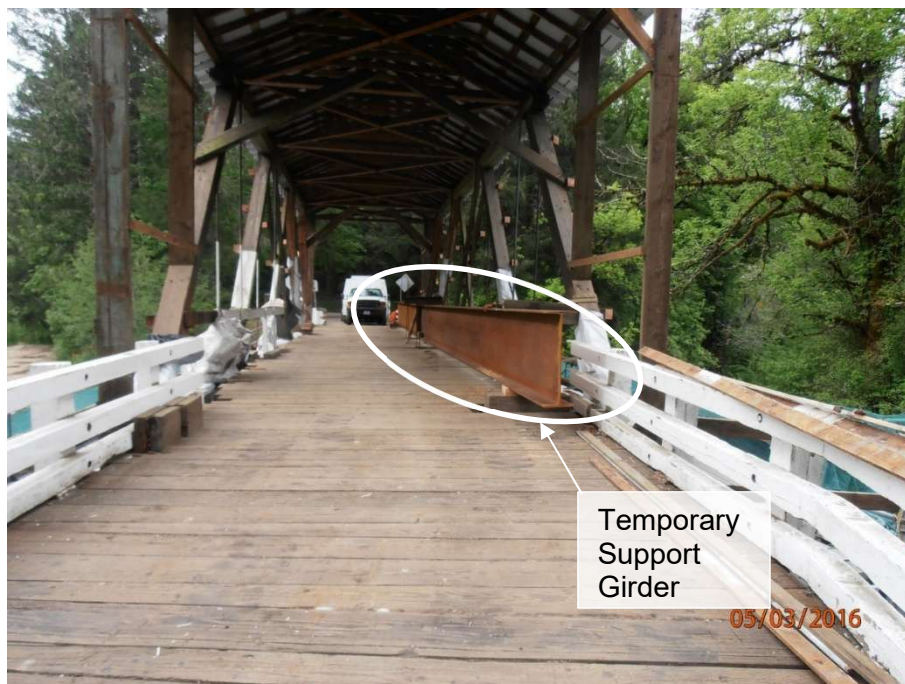
**Figure 3: Truss Temporary Support Steel Girder (Wildcat Covered Bridge, 2016)**

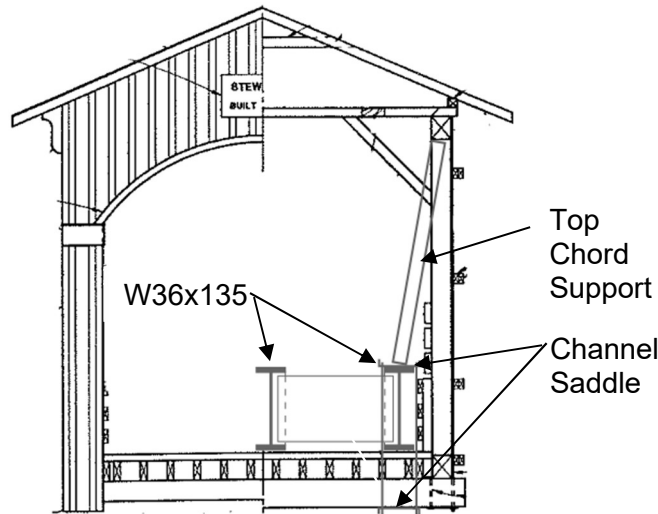
DOWL expects the temporary support to consist of a steel two-girder system, as shown in **Figure 4**, extending approximately 60 feet from direct supports at Bent 3 to Bent 4 based on a preliminary analysis. The system would include attaching each floor beam to the girder and propping up the top chord at each panel point to eliminate the stresses in the top chord, bottom chord, diagonals, and vertical steel hanger rods. Attachment between the girder and floor beam typically consists of a channel section saddle and threaded rods extending from below the floor beam to the top flange of the girder.

**Figure 4: Temporary Support Steel Two-Girder System**

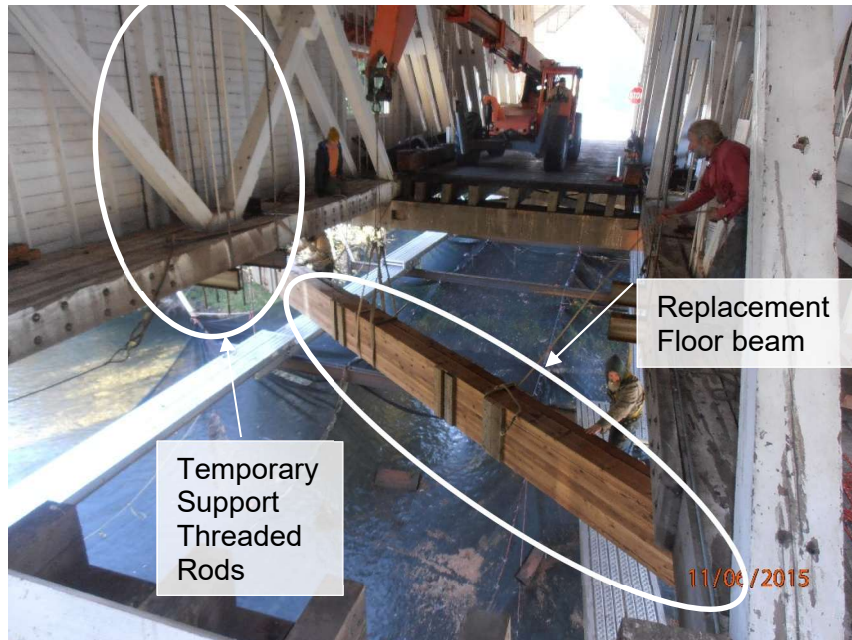
Removal of the deck, stringers, and floor beams can be completed using typical light construction equipment, such as an extendable forklift. The forklift could access the bridge by driving from the south parking lot through the covered bridge. The temporary supports and floor beam replacement would be similar to the County's Office Covered Bridge rehabilitation project, as seen in **Figure 5**.

**Figure 5: Floor beam Replacement (Similar to Office Covered Bridge 2015 Repair)**

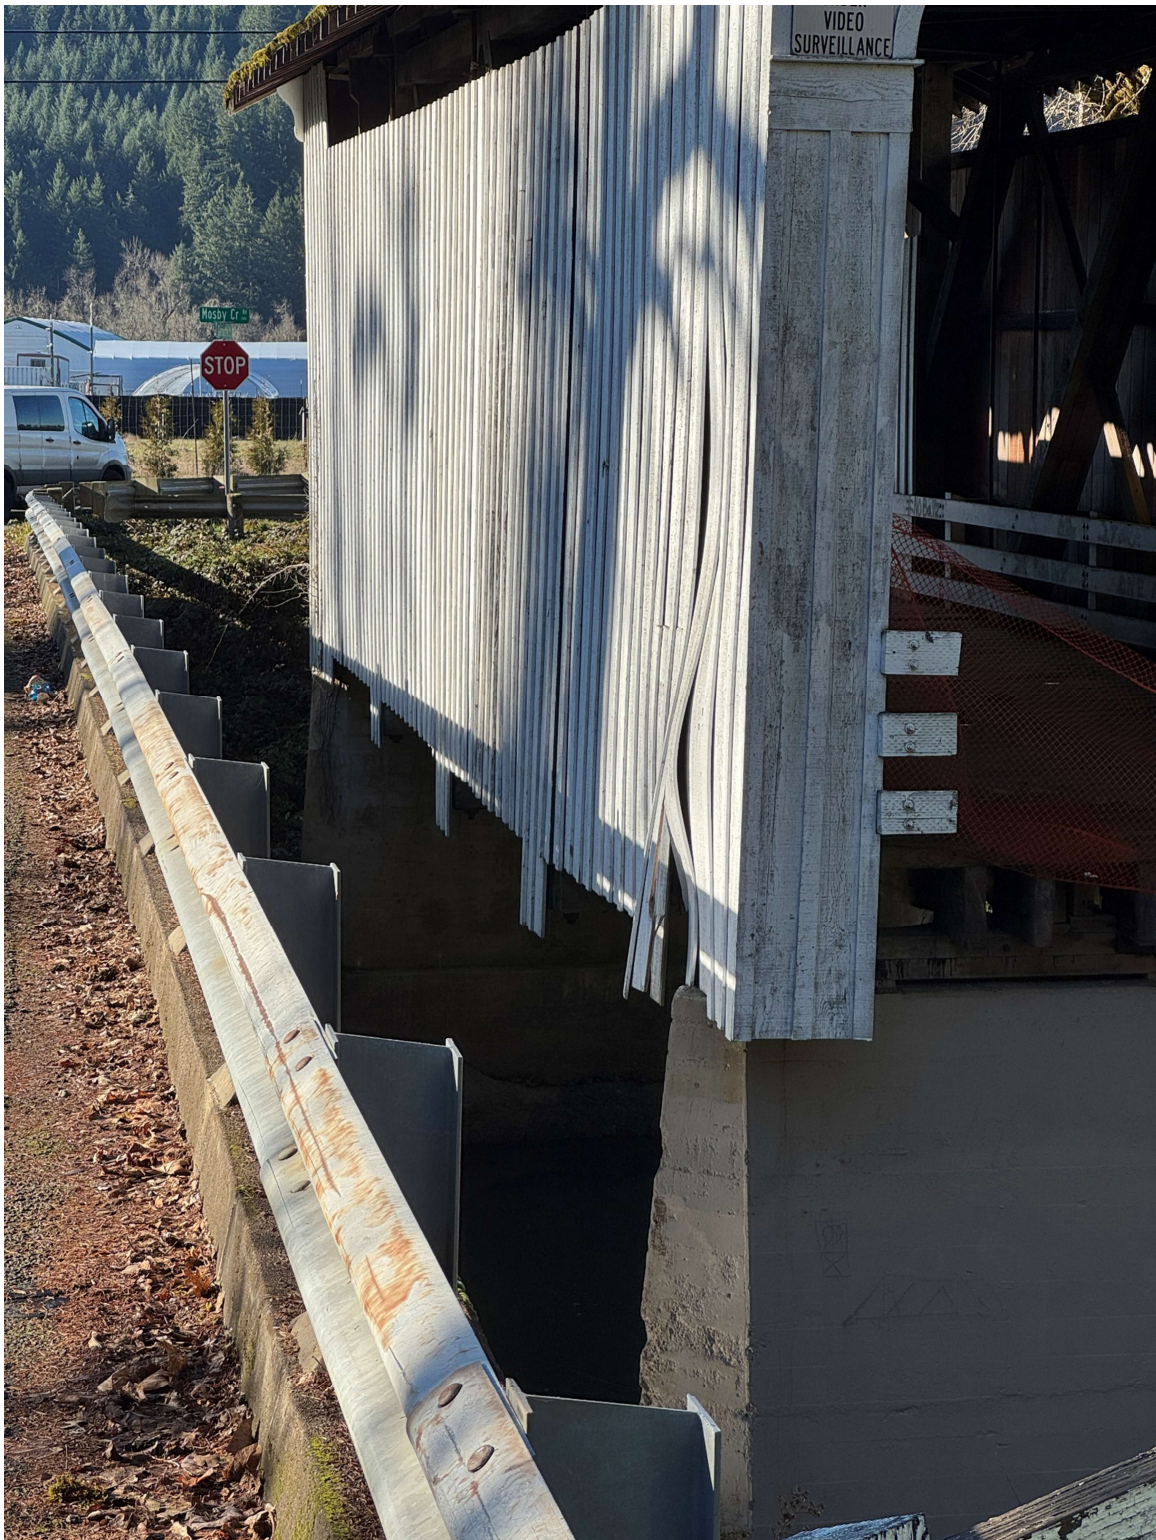
**Figure B1: Stewart Bridge: Siding Buckling Bent 4 SE Corner**

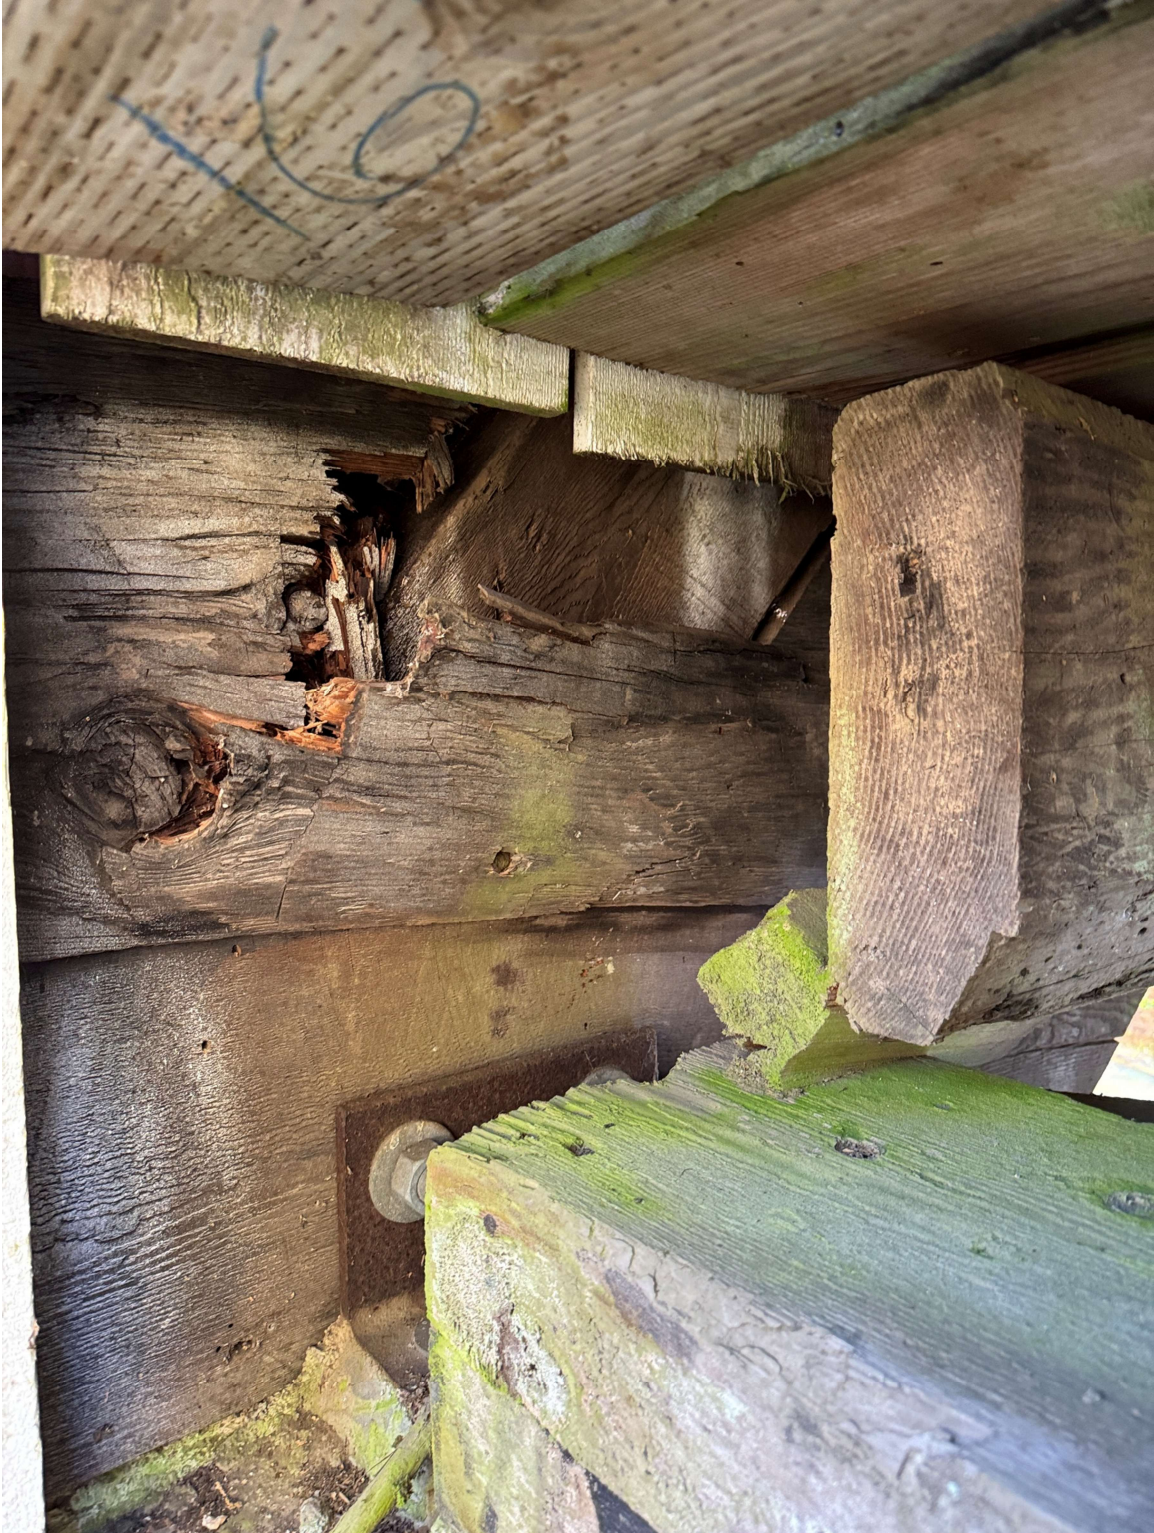
**Figure B2: Stewart Bridge: Crushing at Right Truss Bottom Chord (Bent 4)**

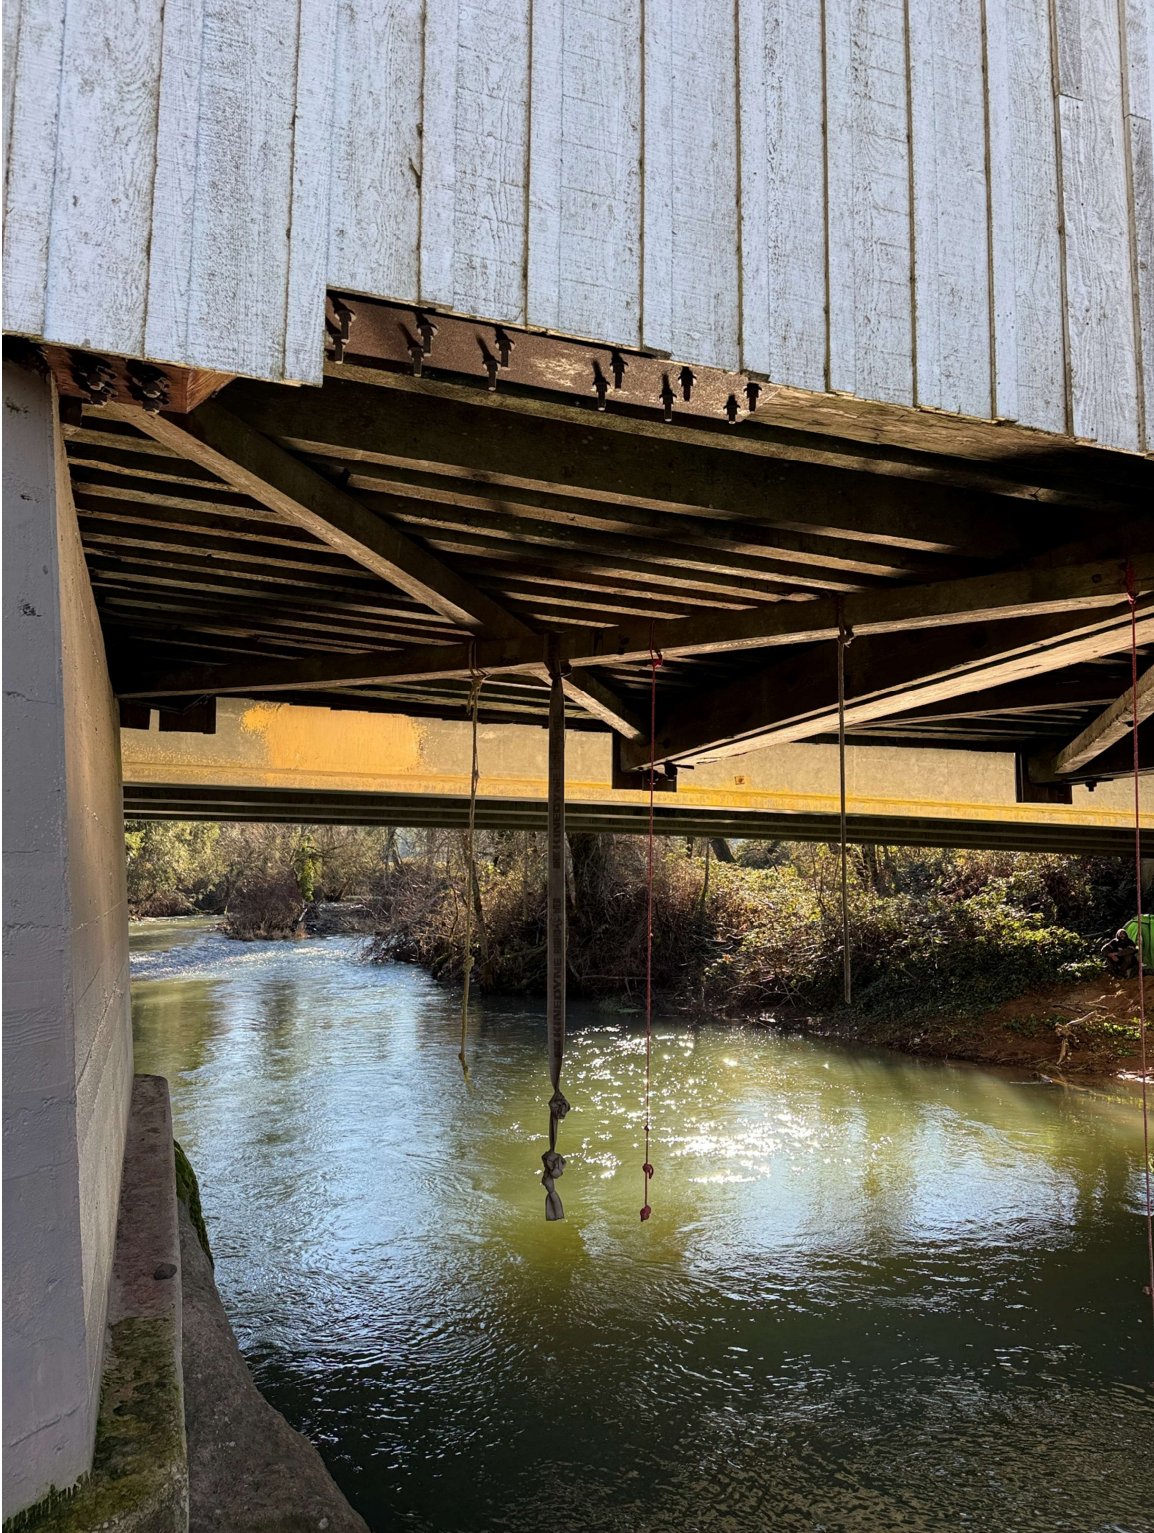
**Figure B3: Stewart Bridge: Downward deflection at floorbeam 3**

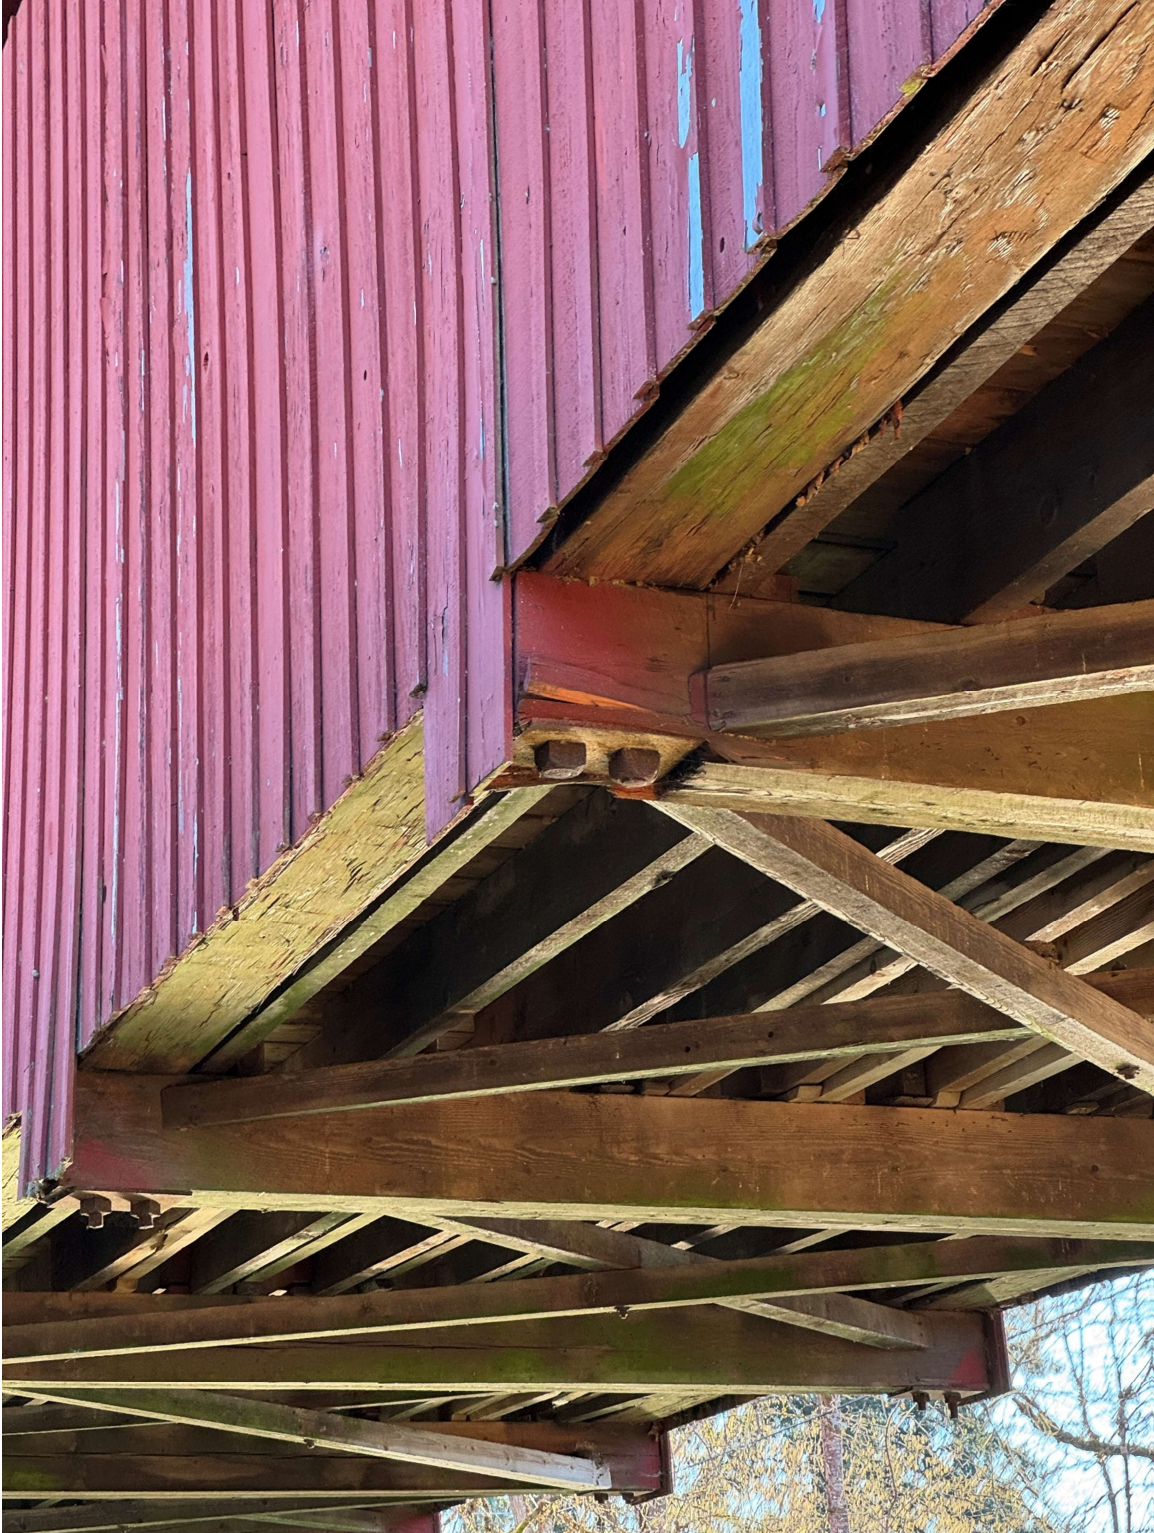
**Figure B4: Currin Bridge: Crushing at floorbeam 6 east**

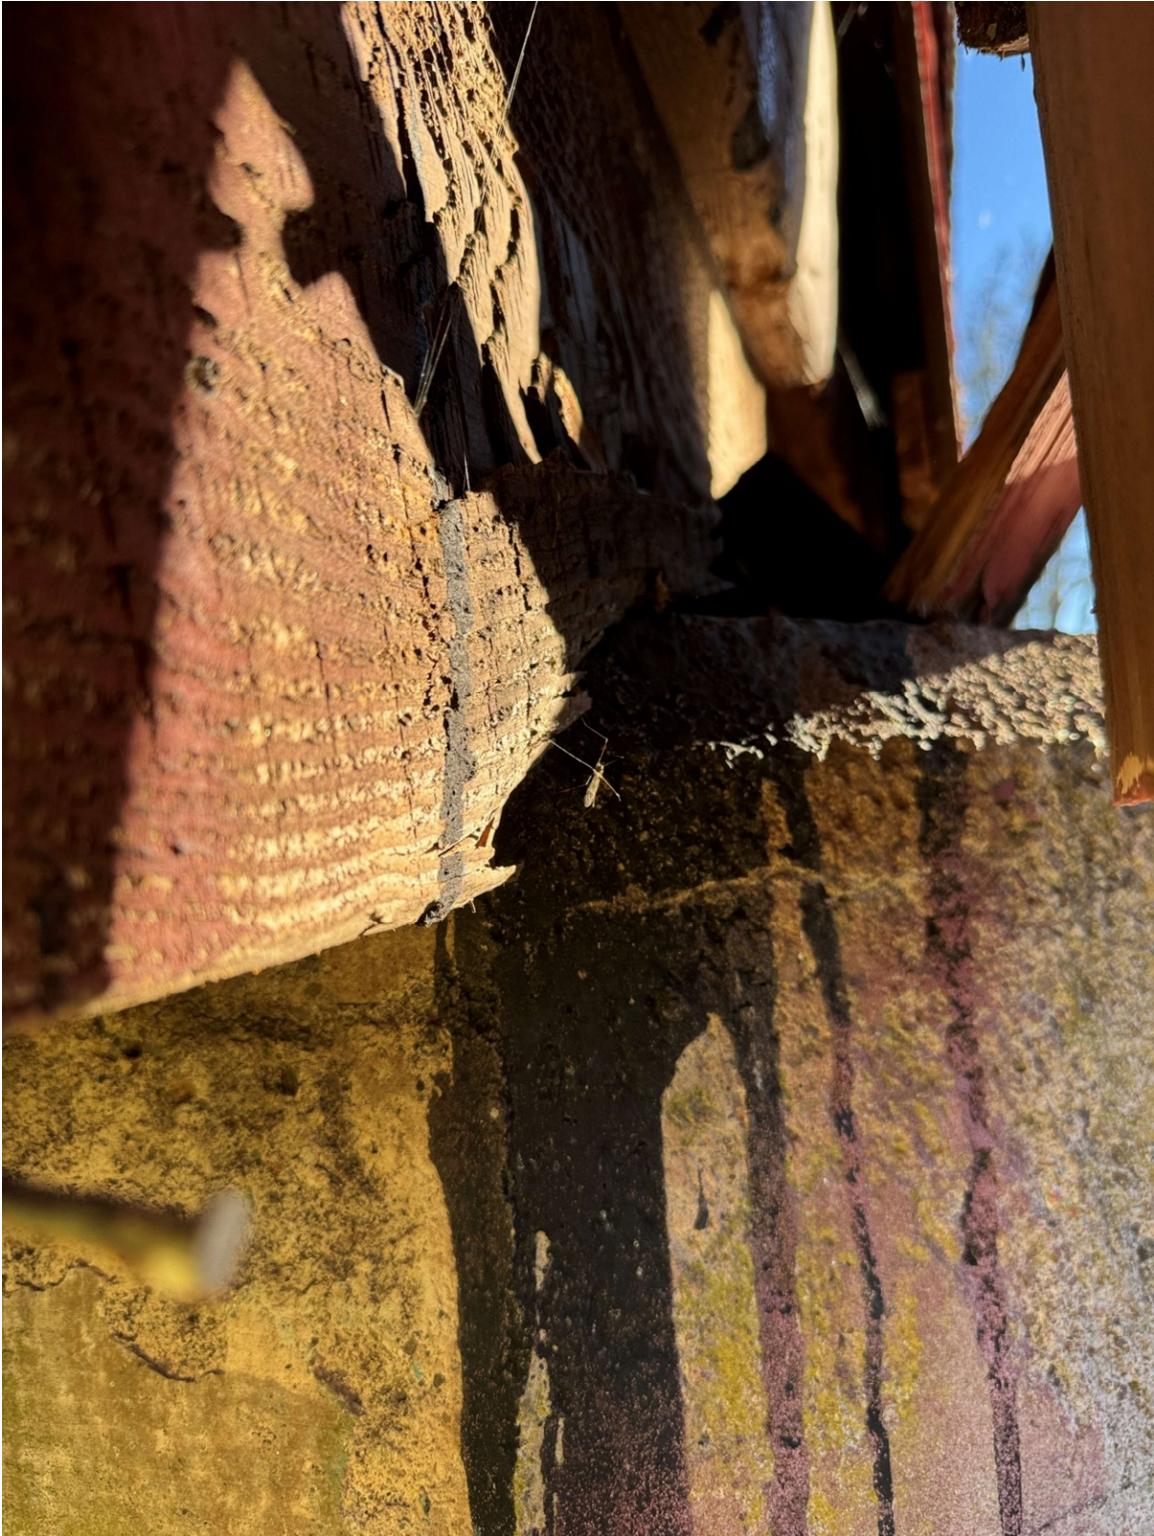
The Bent 6 corbels were also observed, and the west corbel was found to have crushed approximately 3 inches. Although there are signs of distress in the west bottom chord, there was no evidence of a bottom chord failure above the corbel similar to the one observed at the Stewart Covered Bridge and as originally suspected during the November 4, 2025, site visit. The severity of distress in the bottom chord will be confirmed with a full inspection of the bridge.

bottom chord failure. A corbel-crushing failure can induce forces into the bridge that were not originally considered and lead to unsuspected and serious deterioration over time. This type of failure does not put the bridge at immediate risk of collapse like a bottom chord failure would but should be addressed in the near future.

**Figure B5: Currin Bridge: Crushing at Bent 6 West Corbel**

- Replace the roof shingles.
- Replace the L6U6 downstream vertical steel rod.
- Re-tune the truss.
- Replace the sill at Bent 5 west and repair the lower cross-brace.
- Replace the Bent 6 west corbel.
